TWR- 17541 Vol. VII  
ECS #: SS 01010

Flight Set 360L002 (STS-27)  
Field Joint Protection System Final Report  
Volume 7

June 1989

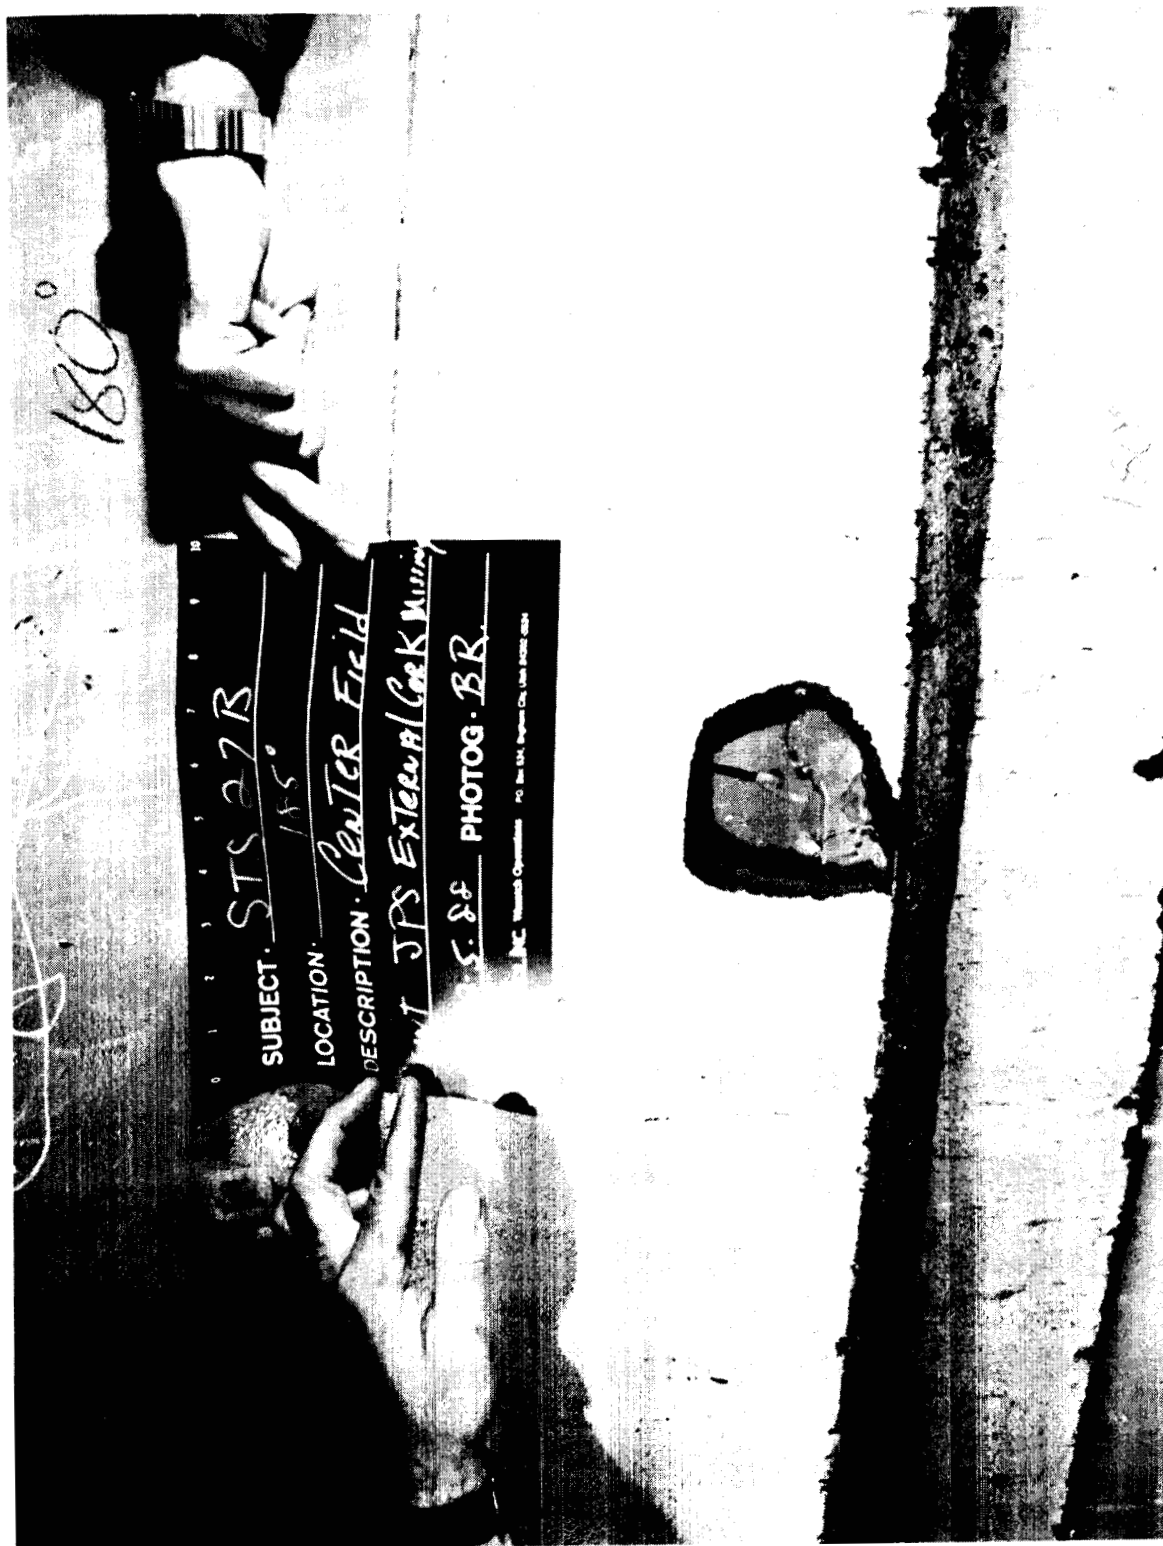
Evaluations of the JPS indicated the system performed as designed during flight. The only unexpected observation was the piece of missing cork on the right center field joint.

A piece of cork (3 x 3 inches) was missing on the right hand center field joint due to the cork not being bonded to the moisture seal. The total void of this region was measured to be 15 inches in length. Due to the heated condition of the cork surrounding the hole, the piece was probably lost during late re-entry. Figure 3 is a photograph of this void.
